Broken Head Stud

XK Motor 4.2Ltr

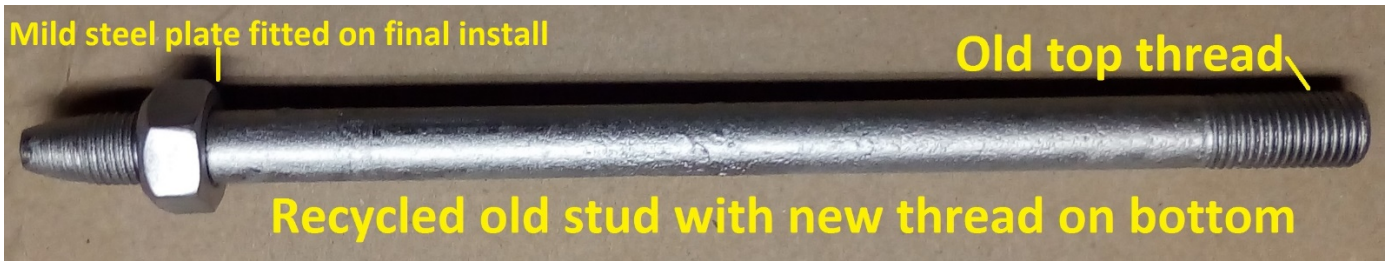
Mild steel plate fitted on final install

Old top thread

Recycled old stud with new thread on bottom

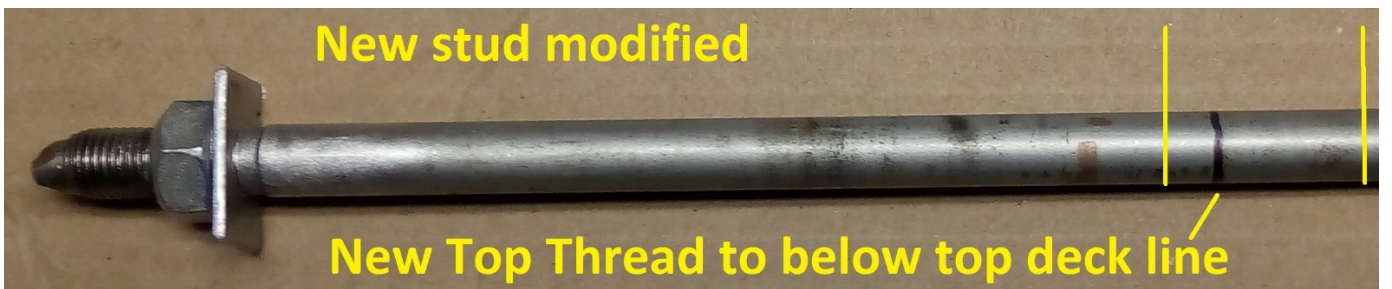
New stud modified

New Top Thread to below top deck line
