**XK Motor 4.2Ltr**

**Don't despair** there is hope with a fix I have done on my own engine (XJ6 S2) & others I call "The sandwich bolt", this method works when you just need the problem fixed & back driving with a minimum of fuss & expense. Here's a step by step guide with graphics to repair the problem without removing the cyl/ head.

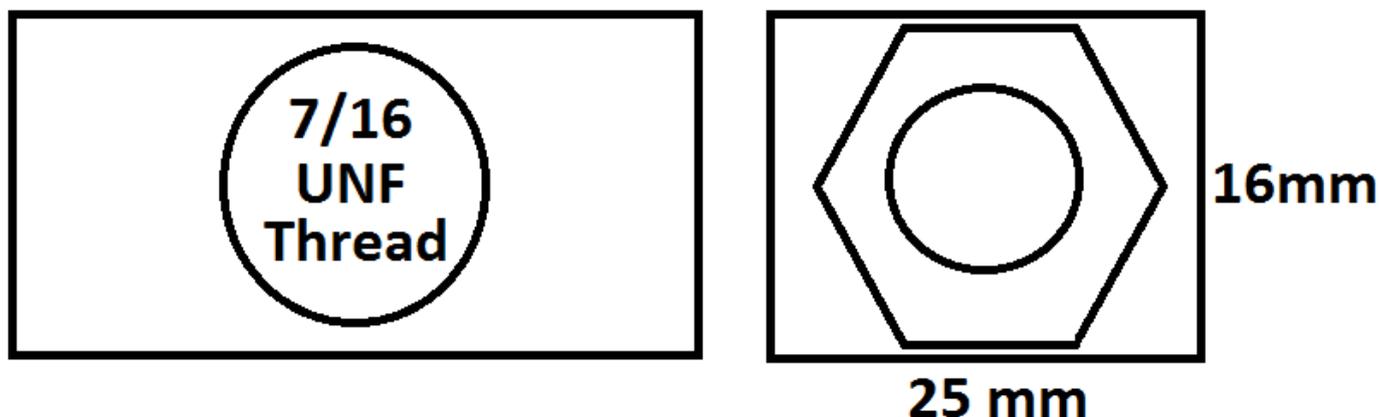
**Step 6:** The flat Plate – follow the diagram below.

### Trim after tapping thread

**Step 5:** Flat steel plate – in most cases this will be necessary to stop the bolt from turning when you try to tension the new bolt, the new nut will jam up inside the water gallery under the cylinder block deck but not enough to stop the bolt from turning, the flat plate will provide enough lock up on the bolt and will continue to get tighter as you tension the dome nut.

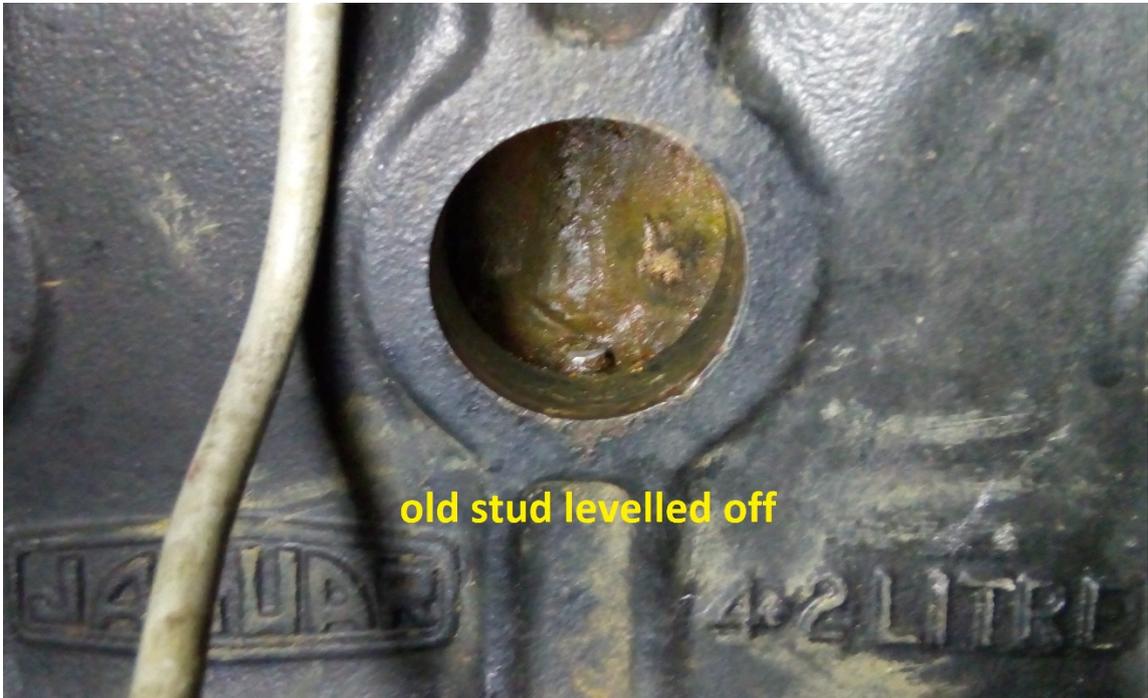
old stud levelled off

**Step 7:** Now you're ready to fit the replacement, graphics below show some of the stages mentioned. After final check of the modified bolt replacement thread lengths ensuring you can properly tension the top dome nut – smear a little non hardening sealer on both sides of the top washer – feed the bolt through the head to access the bottom thread in the water gallery, screw on the flat plate first then the new nut, with the flat plate running length ways with the block – push the bolt back up so the top thread comes through.

Fit the top washer & then dome nut, tension the nut to recommended setting – usually 50 ft/lb 54ft/lb max/. While you are tensioning the bolt you'll feel the resistance on the bolt as the flat plate edges mould into the block, after tensioning clean surface for the new welsh plug & fit.

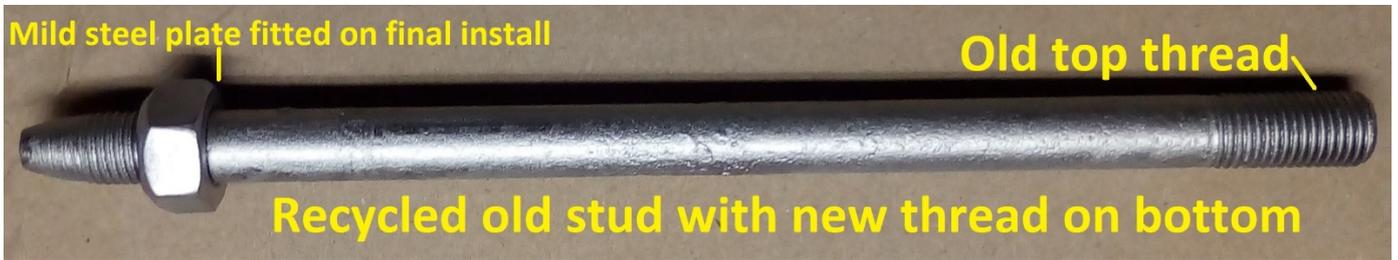
Mild steel plate fitted on final install

Old top thread

Recycled old stud with new thread on bottom

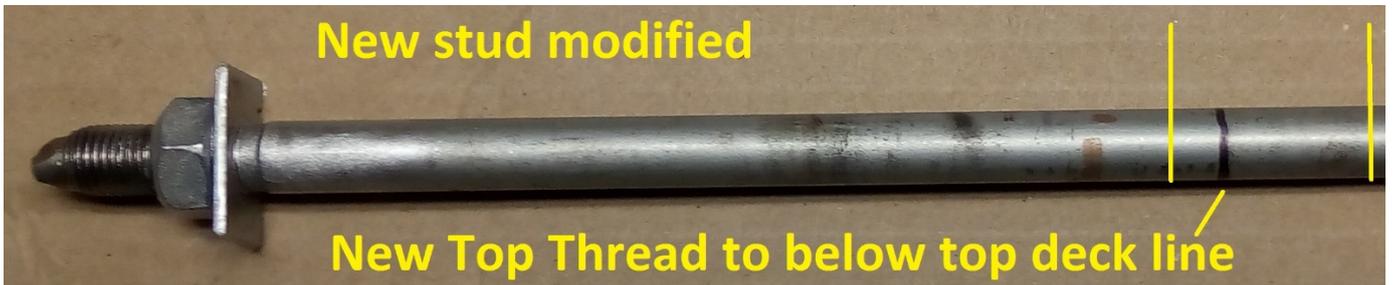
New stud modified

New Top Thread to below top deck line
