Broken Head Stud

XK Motor 4.2Ltr

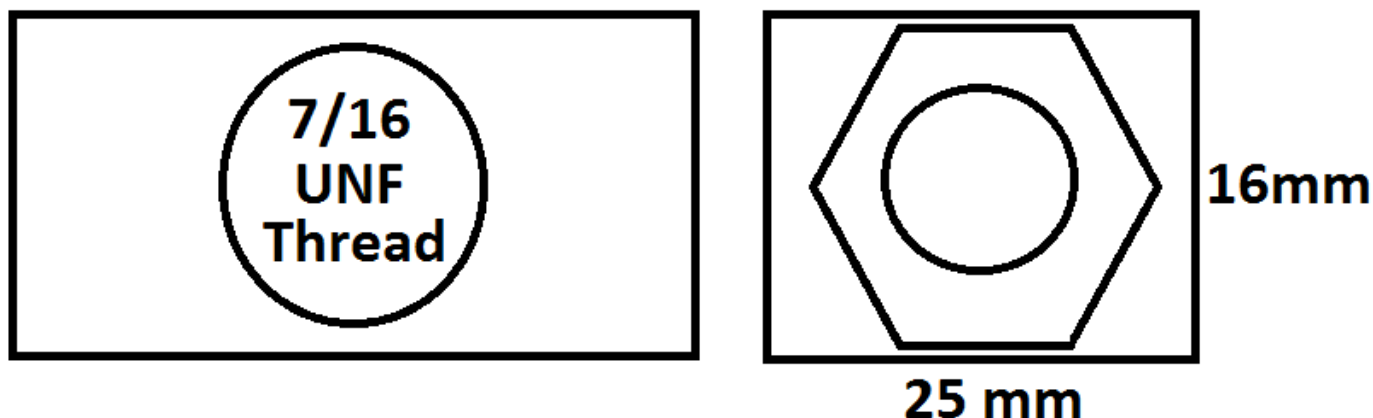
Trim after tapping thread

Step 5: Flat steel plate – in most cases this will be necessary to stop the bolt from turning when you try to tension the new bolt, the new nut will jam up inside the water gallery under the cylinder block deck but not enough to stop the bolt from turning, the flat plate will provide enough lock up on the bolt and will continue to get tighter as you tension the dome nut.

Step 6: The flat Plate – follow the diagram below.

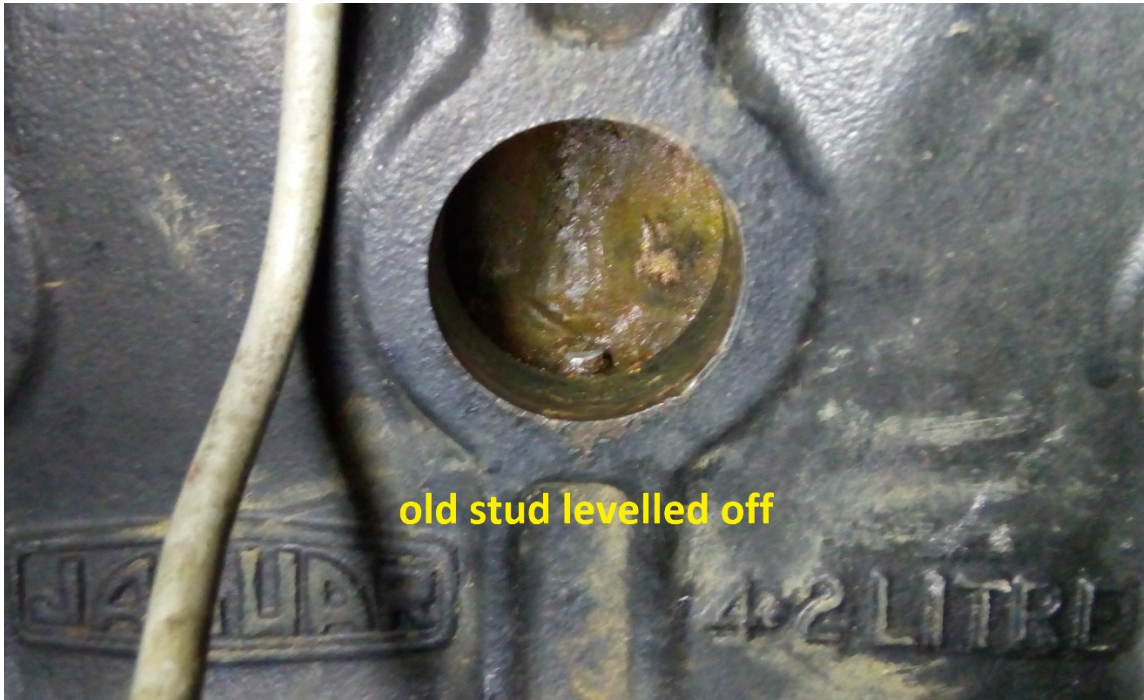
old stud levelled off

Step 7: Now you're ready to fit the replacement, graphics below show some of the stages mentioned. After final check of the modified bolt replacement thread lengths ensuring you can properly tension the top dome nut – smear a little non hardening sealer on both sides of the top washer – feed the bolt through the head to access the bottom thread in the water gallery, screw on the flat plate first then the new nut, with the flat plate running length ways with the block – push the bolt back up so the top thread comes through.

Fit the top washer & then dome nut, tension the nut to recommended setting – usually 50 ft/lb 54ft/lb max/. While you are tensioning the bolt you'll feel the resistance on the bolt as the flat plate edges mould into the block, after tensioning clean surface for the new welsh plug & fit.

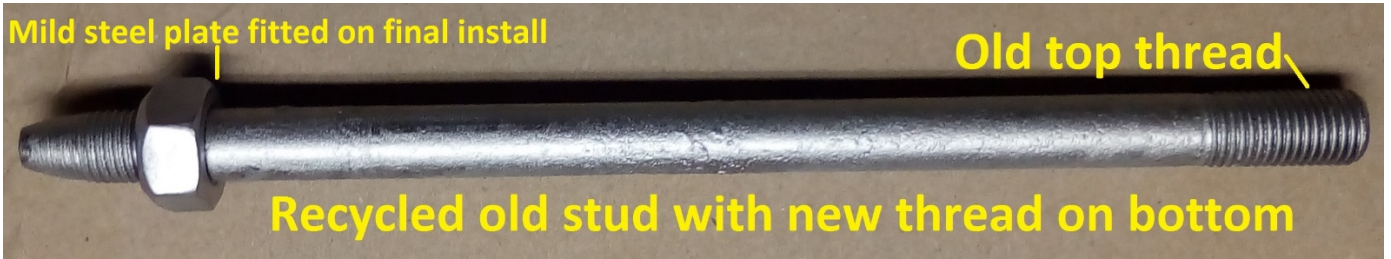
Mild steel plate fitted on final install

Old top thread

Recycled old stud with new thread on bottom

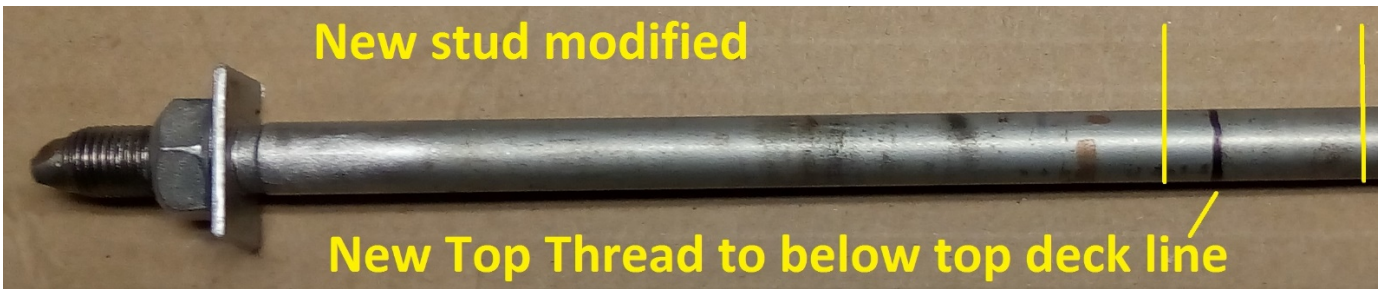
New stud modified

New Top Thread to below top deck line
